## Technical Report No. 704062401282-00 Dated 2024-05-30

LR5-54HTDB-420M

Test specifica-IEC 61730-2:2016 MST 23 class A fire test.

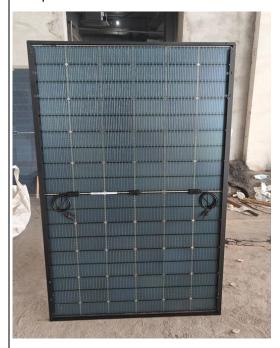
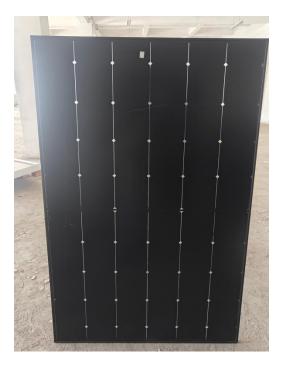
# Test photos: **GDP240437-1**:

## Posted test

Supplementary information: The backpanel has broken, but nothing has been blown off or fallen off the test deck in the form of flaming or growing brands.

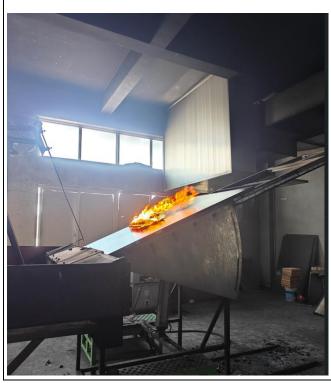
# GDP240437-2:

## Back

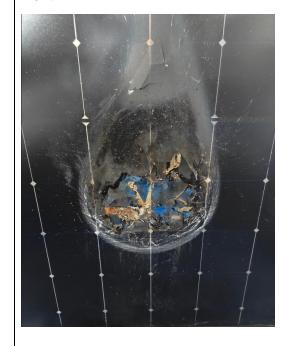
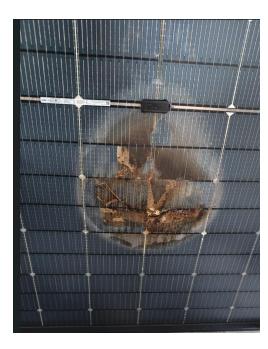
## After test:

The backpanel has broken, but nothing has been blown off or fallen off the test deck in the form of flaming or growing brands.

Front
